MultiCam

MultiCam 6.18.2 Release Notes

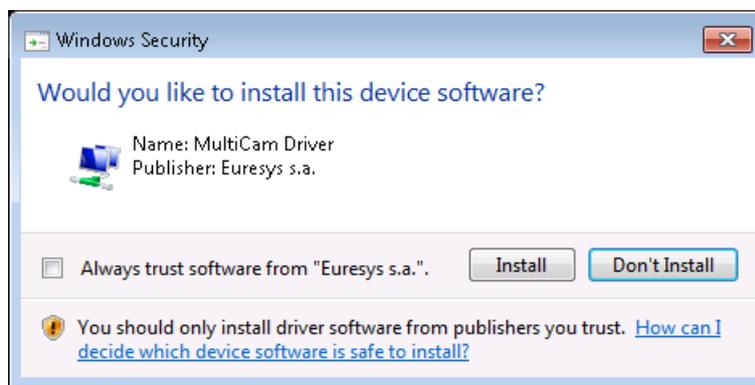
The following Windows Security warning message may occur at driver installation on Microsoft Windows:

This Windows security warning message occurs when the Euresys code-signing certificate is missing from the "Trusted Publishers" Windows Certificate store. This happens, for instance, when the Euresys code-signing certificate must be renewed.

Follow the instructions to install the current Euresys code-signing certificate into the "Trusted Publishers" Windows certificate store.

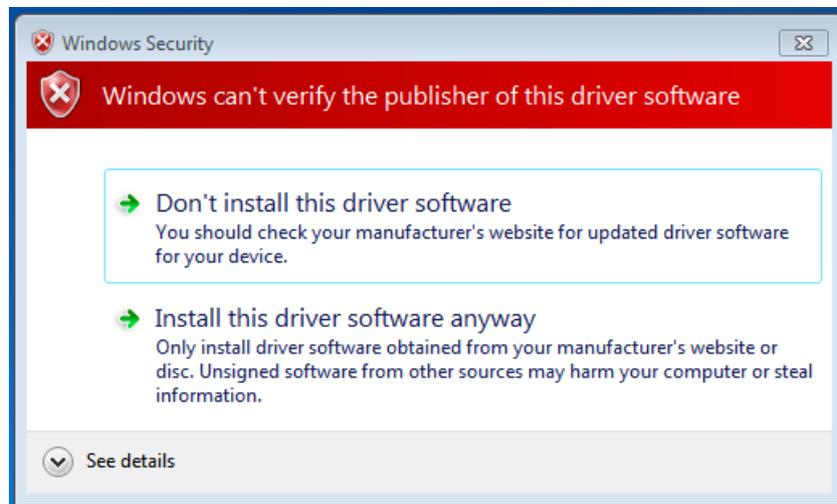
The following Windows Security warning message may occur at driver installation on Microsoft Windows:

This Windows security warning occurs when the **GlobalSign Root CA - R6** certificate is missing from the Windows certificate store.

This issue can be solved by installing this missing certificate which can be downloaded [here](#) on the GlobalSign website then installed in the Trusted Root Certification Authorities (local computer) certificate store.

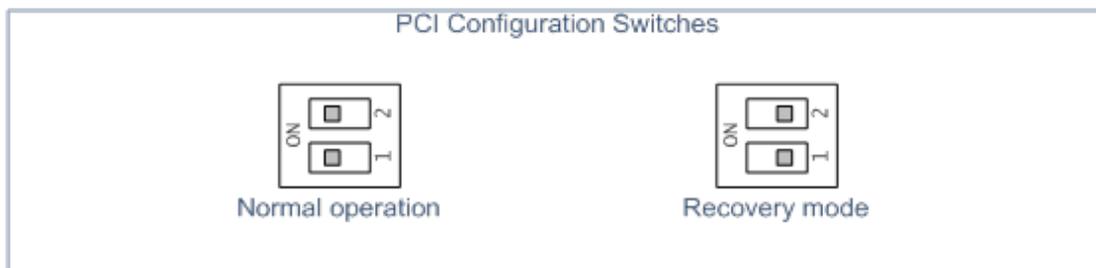
These boards feature a set of configuration switches. For normal operation, both switches must be in the ON position.

Should recovery mode be enabled by error, the Grablink board appear respectively as "GRABLINK Base (Recovery)", "GRABLINK DualBase (Recovery)", "GRABLINK Full (Recovery)" and "GRABLINK Full XR (Recovery)" in Windows Device Manager and is not functional.

To restore normal operation, power off the PC, change the switches to normal position and then reboot.

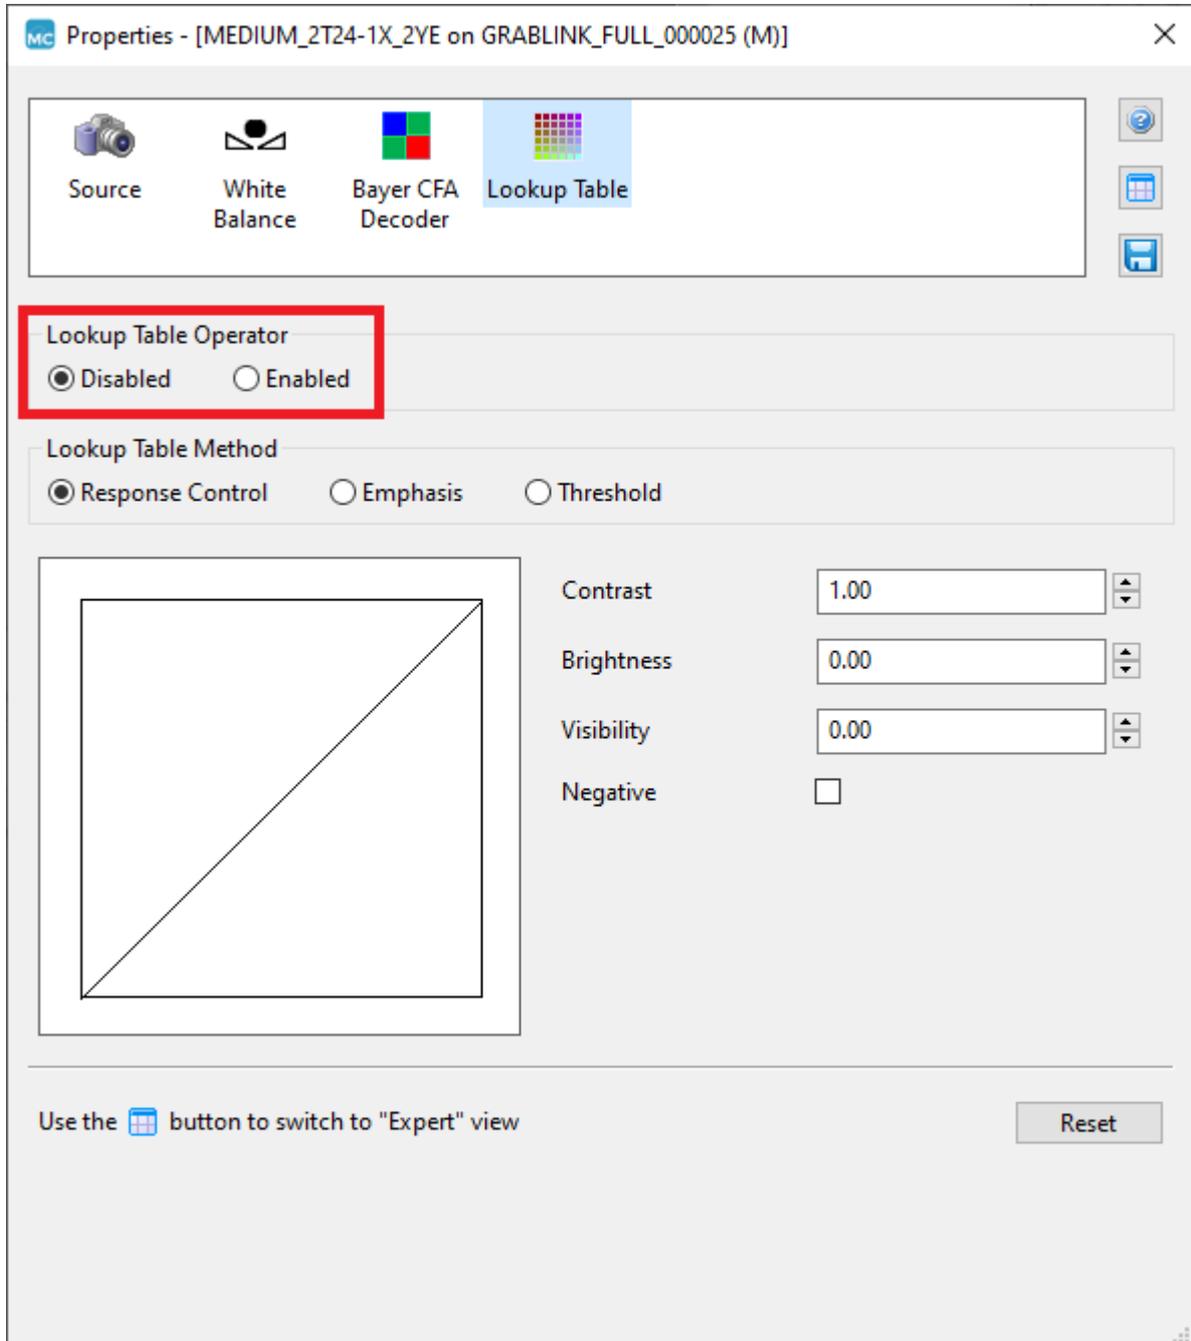
Since this release of MultiCam, the LUT Operator is disabled by default in MultiCam Studio. A new Lookup Table Operator control has been added in the Lookup Table panel of MultiCam Studio to enable or disable the LUT Operator.

NOTE The maximum input bit-depth of the LUT Operator is 12-bit. The Lookup Table Operator should remain disabled when acquiring 14-bit and 16-bit pixels in MultiCam Studio.

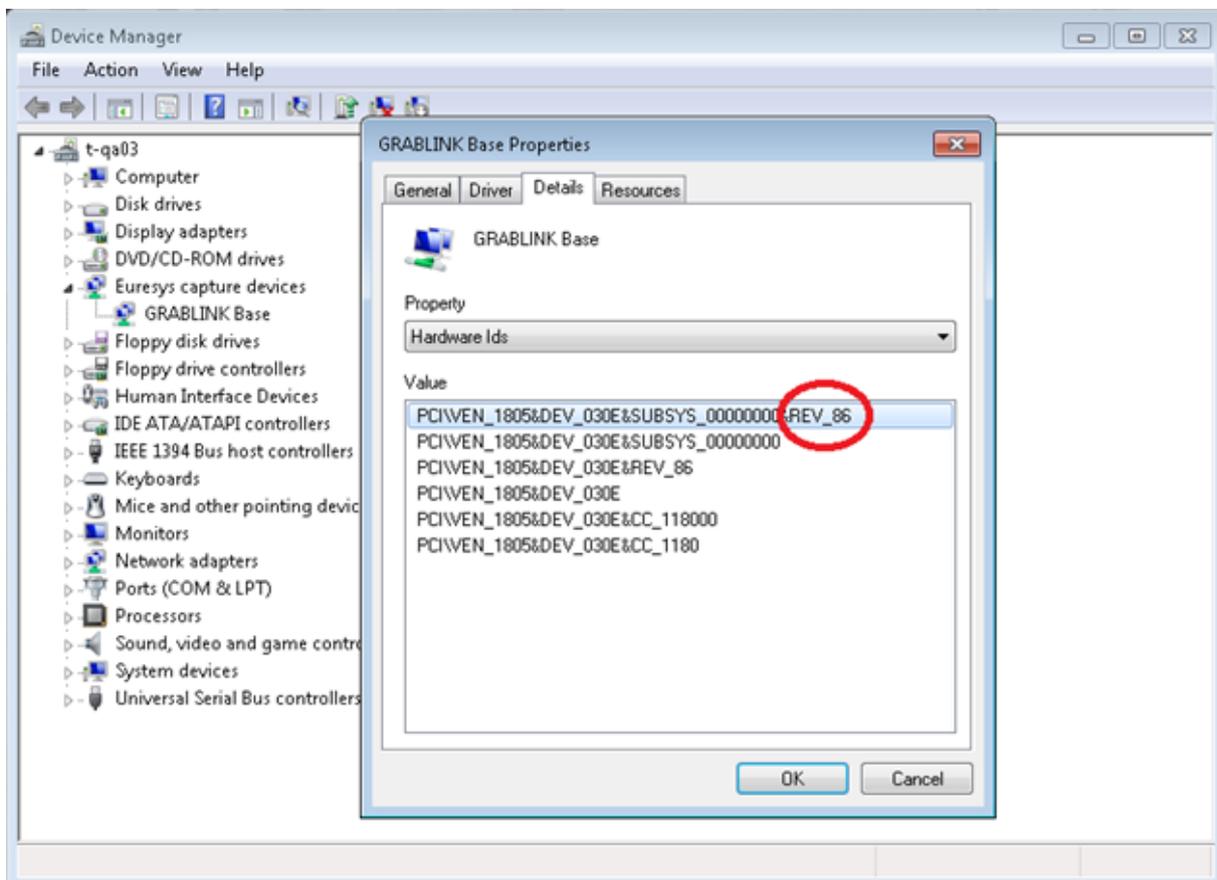
Windows Device Manager – Properties Dialog showing the PCIe endpoint version number in hexadecimal format

There are two methods to read the PCIe endpoint version number of a Grablink card:

1. Using Windows Device Manager – Properties Dialog
2. Using MultiCam Studio – Board Information Dialog

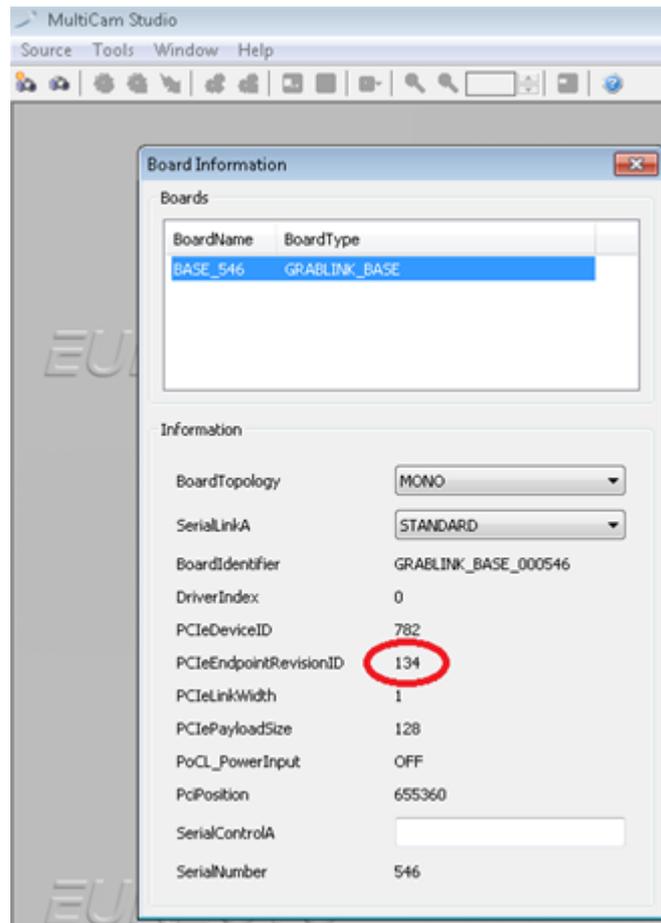
MultiCam Studio – Board Information Dialog showing the PCIe endpoint version number in decimal format
